Summary Report

Trial of C-V2X Radio Equipment Operating in the 5905-5925 MHz Band

Applied Science and Technology Research Institute Limited
5th Floor, Photonics Centre
2 Science Park East Avenue
Hong Kong Science Park, Shatin
New Territories, Hong Kong
Telephone: +852 3406 2800
Fax: +852 3406 2801
Web: www.astri.org

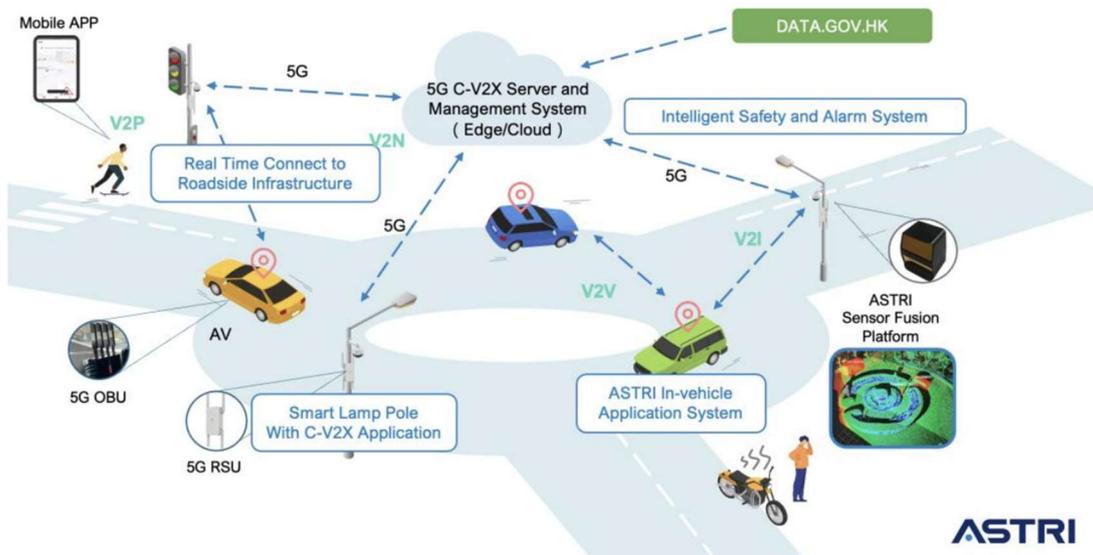
Figure 1-1 C-V2X System Conceptual Diagram

Vehicle to Everything (V2X) is a new generation wireless communication system technology for vehicles and different road users, which includes Vehicle to Vehicle (V2V), Vehicle to Pedestrian (V2P), Vehicle to Infrastructure (V2I) and Vehicle to Network (V2N). Cellular V2X (C-V2X) is based on communication technology such as 3G, 4G or even 5G, which provides a wireless network system connecting vehicles, including Long-Term Evolution (LTE)-V2X. The following figure illustrates the C-V2X network system.

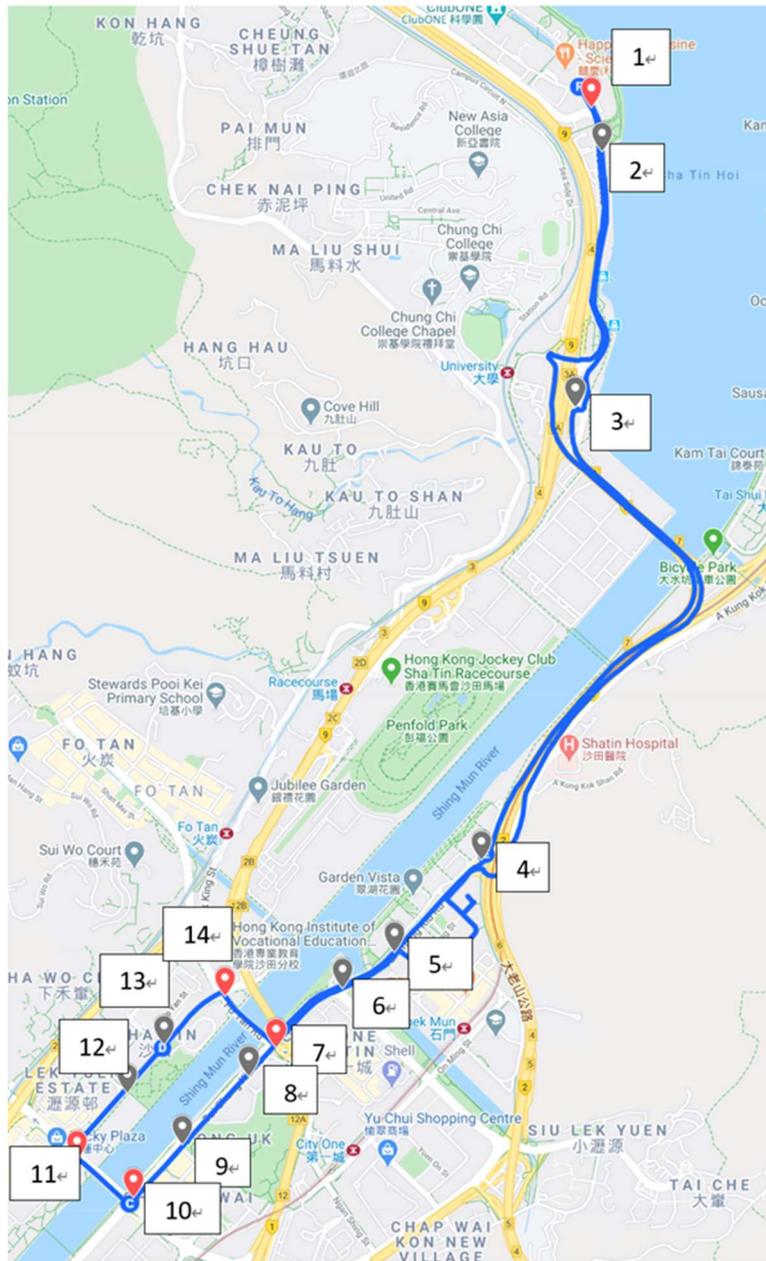
Figure 2-1 Trial Sites in Shatin

14 RSUs were installed at this Trial Site. The C-V2X Trial Site route was 14.1 km long. 5 RSUs were installed on Traffic Light Controller (TLC) poles (red marker) and 9 RSUs were installed on lamp poles (grey marker).

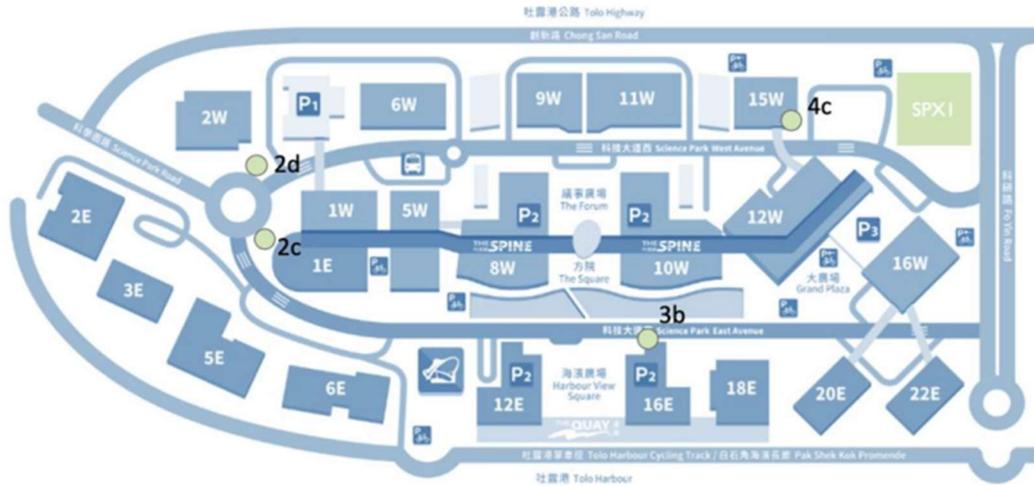
Figure 2-2 Trial Sites at Hong Kong Science Park

4 RS1000 RSUs were installed inside the HK Science Park. All of them were configured to the 20-MHz Channel.

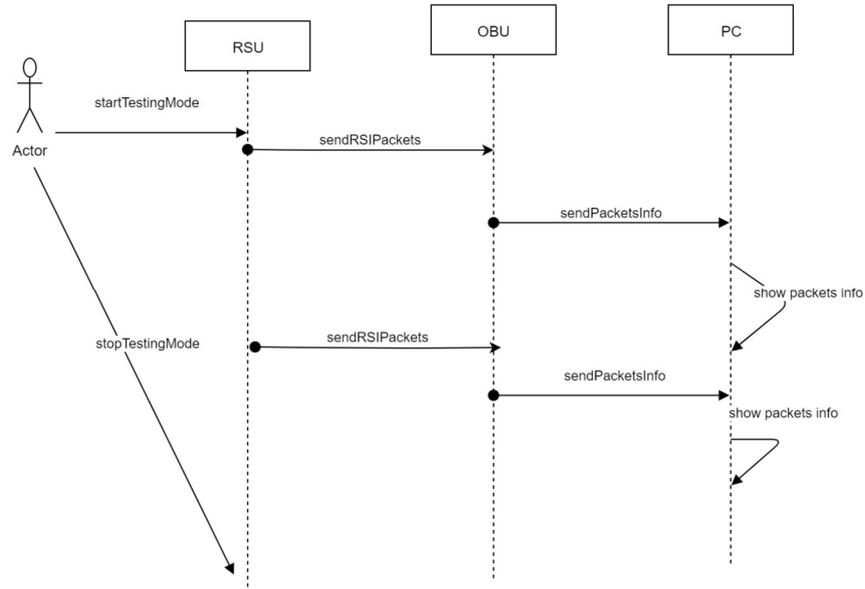
Figure 3-1 Signal Strength and Packet Loss Test Solution

Since the deployment environment of RSUs will affect working performance of RSUs, we use software tools to trigger RSU to broadcast a certain type of message, such as Roadside Information (RSI) messages periodically and use acceptance tool on PC to check the received messages by testing OBUs real time.

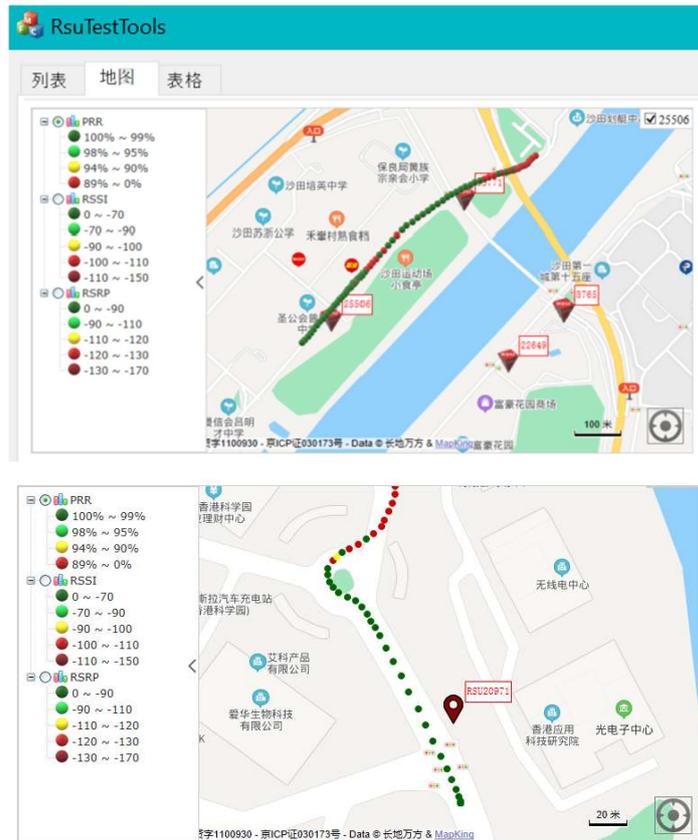
Figure 3-2 RsuTestTool Screenshots during Testing

We used OBUs and its *RsuTestTool* program to collect the data sets for all 14 RSUs. Screen shots of the *RsuTestTool* captured during our test runs are shown below as examples.

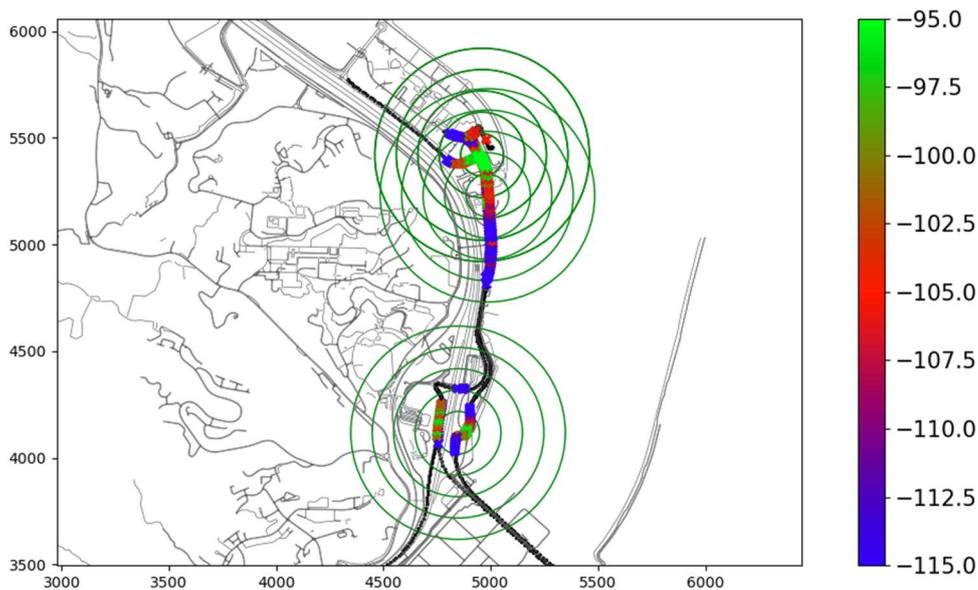
Figure 3-3 Overall Ma Liu Shui Area Coverage

In the Ma Liu Shui section of our demo route, RSU1-3 had been deployed but not fully covering the whole route of the region, since RSU2 and RSU3 were about 1.2km apart and we would have to deploy another RSU to cover the gap in-between. Signals from RSU1 and RSU2 could not quite reach within the Science Park area, due to the large commercial buildings causing blockages. RSU3 had the worst road coverage and was unable to cover all sections of the demo route within 200m range. This was due to the RSU being deployed at the bottom of the slope, causing signal blockages.

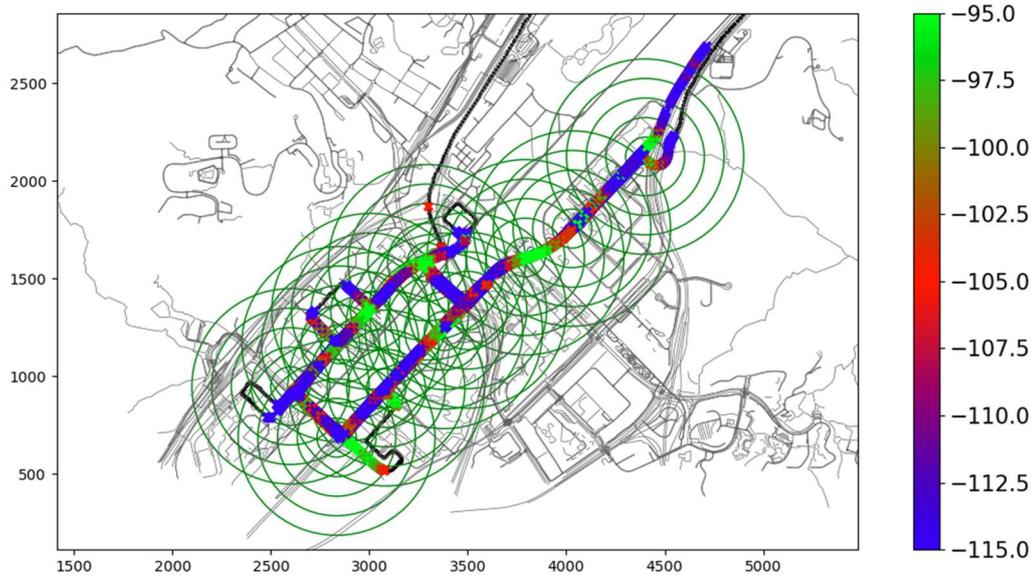
Figure 3-4 Overall Shing Mun River Area Coverage

In the Shing Mun River section, nearly full coverage of the demo route was obtained by RSU4-14 in that area. At later stages, we shall investigate not only the coverage of the demo route's main roads, but also all the inner roads and any location vehicles can access within Sha Tin.

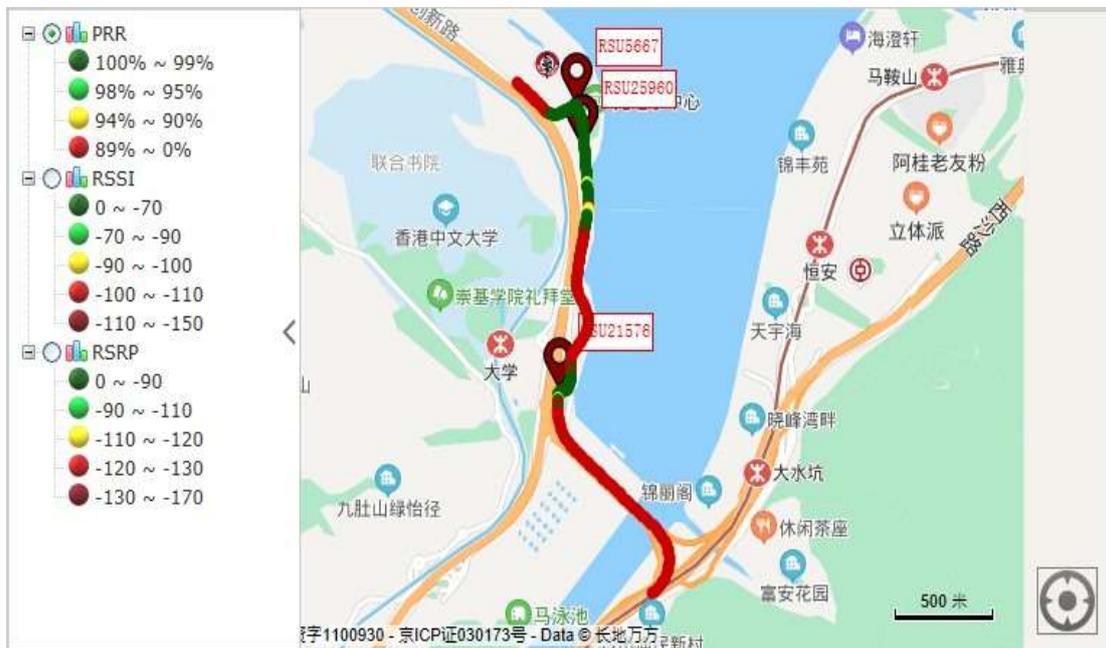
Figure 3-5 Signal Strength Test Results – RSUTestTools Capture (RSU1-3)

The Signal Strength (PRR) was tested in Stage 2. The following screen captures were the test results of PRR.

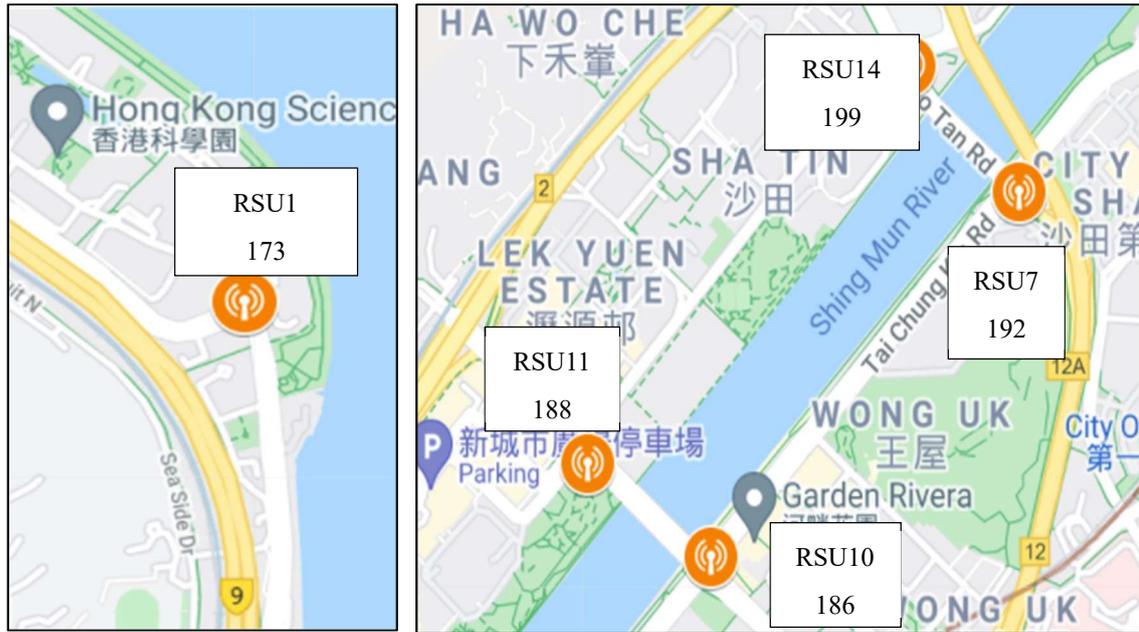
Figure 3-8 Tested RSUs Locations

Until this stage, the Packet Loss test had been conducted on 5 RSUs that were connected to light controller connection. At a later stage, this test would be expanded to other RSUs in the project.

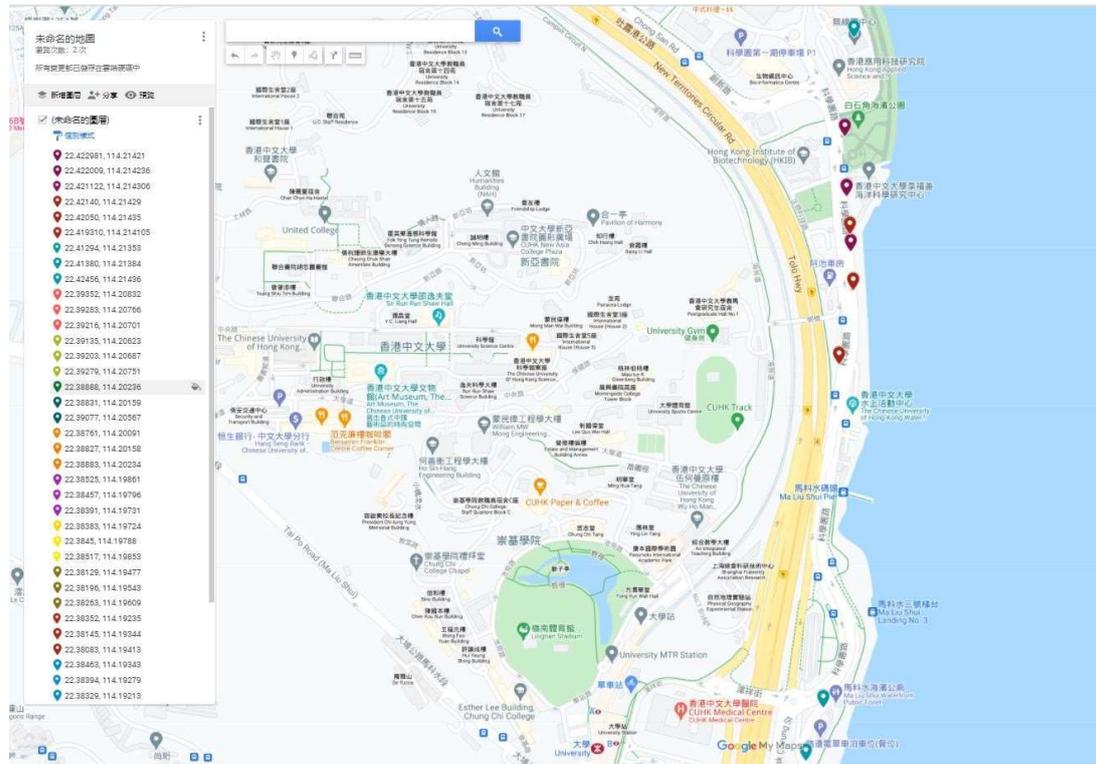
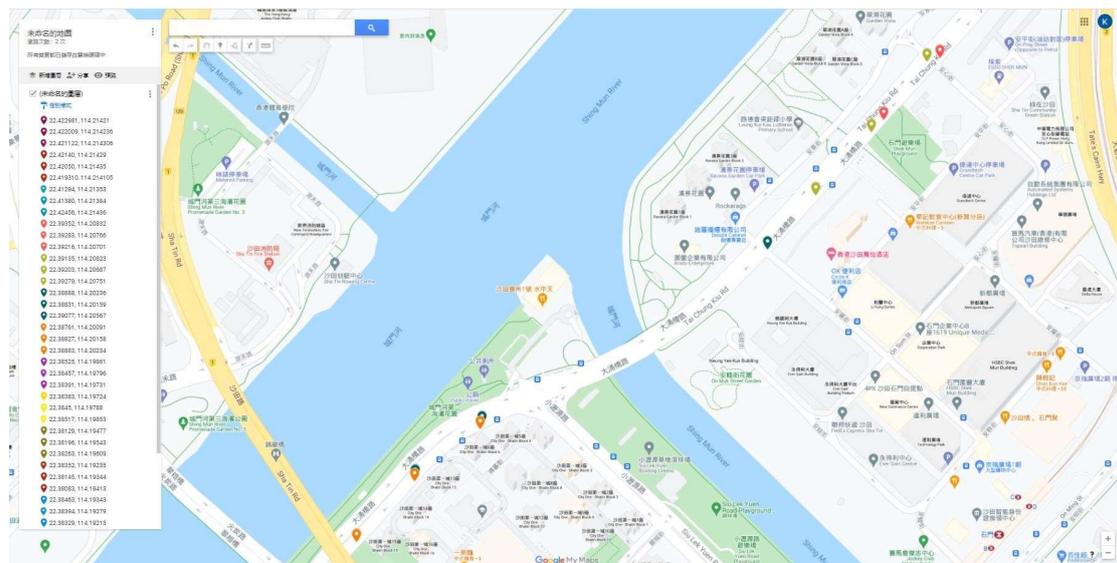
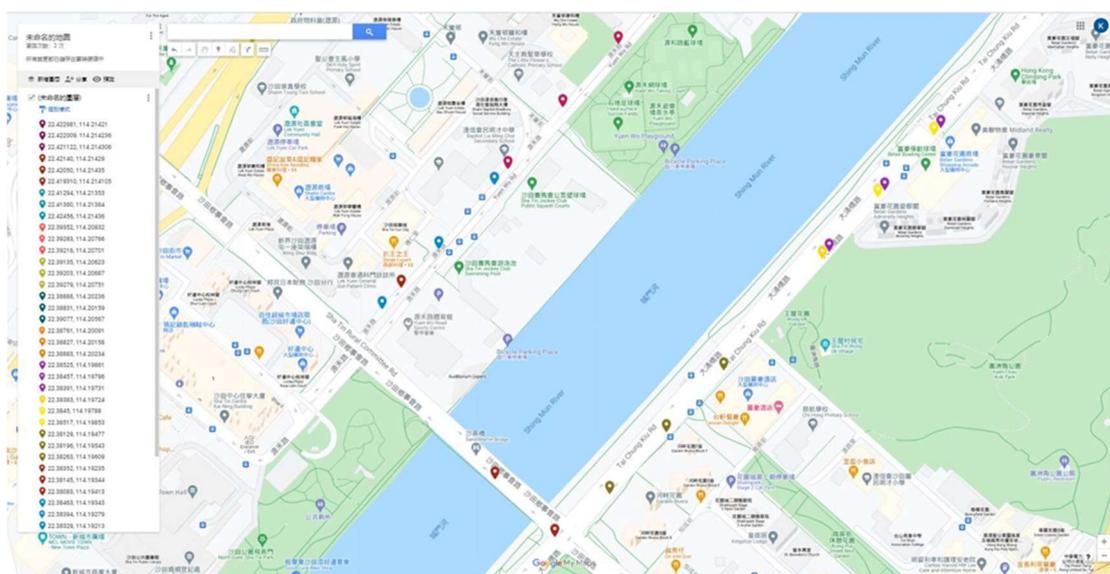
For each of the 14 installed RSUs, we selected three locations with different distances to RSU (100m, 200m, and 300m) to test the Packet Loss.

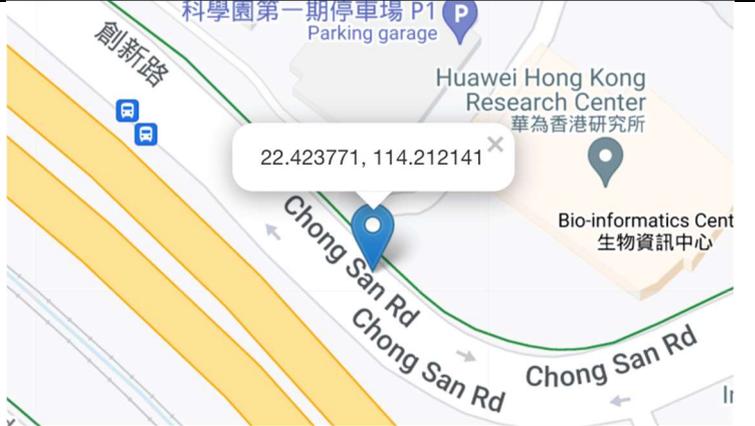
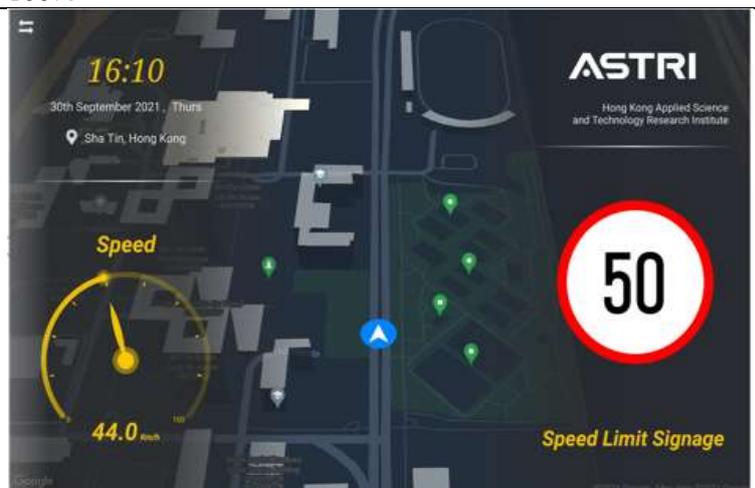
Table 4-4 Speed Alert Warning Test Results

When host vehicle travelled on the road with a speed limit (e.g. 50km/h, 70km/h, etc.), the “Speed Alert” would be sent from C-V2X RSU to the ASTRI’s In-vehicle software via C-V2X OBU installed in the host vehicle, using V2I PC5 communications channel. ASTRI’s In-vehicle software and Display App in the host vehicle would generate and display the “Speed Alert” to alert the driver.

<p>Event sending interval</p>	<p>1s</p>
<p>Actual logged alarms</p>	<p>10 (02:42:31.533 ~ 02:42:40.476)</p>
<p>Alarm should be logged during the period (02:42:31.533 ~ 02:42:40.476)</p>	<p>10</p>
<p>Success rate</p>	<p>100%</p>
<p>Tablet App Capture</p>

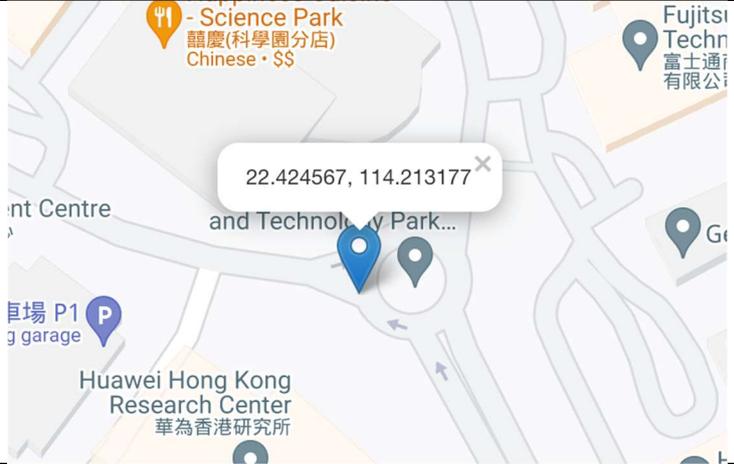
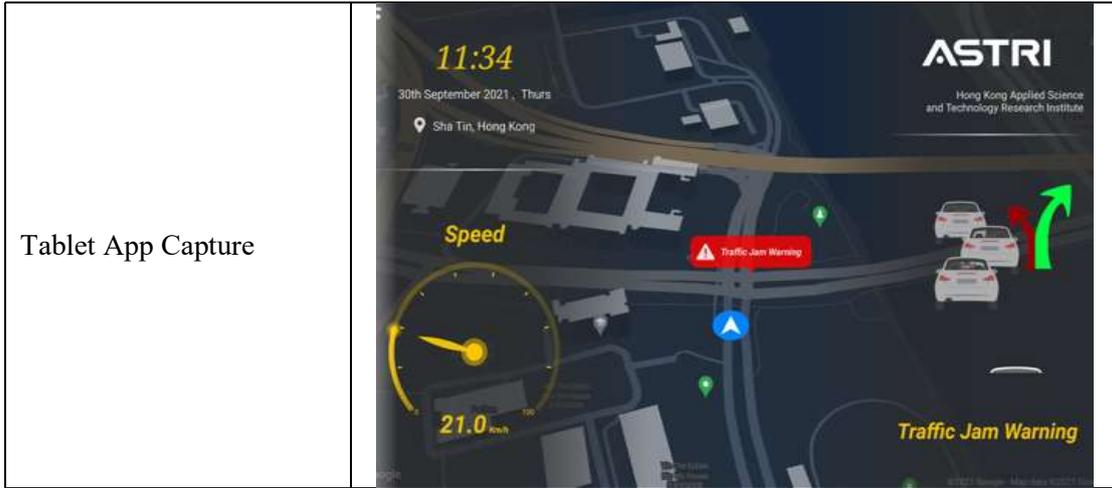
Table 4-5 Congestion/Traffic Control Warning Test Results

When host vehicle travelled on the main road, if there was a “traffic congestion/control” ahead (says 300m ahead), the “Congestion/Traffic Control Warning” would be sent from C-V2X RSU to the ASTRI’s In-vehicle software via C-V2X OBU installed in the host vehicle, using V2I PC5 communications channel. ASTRI’s In-vehicle software and Display App in the host vehicle would generate and display the “Congestion/Traffic Control Warning” to alert the driver.

<p>Event sending interval</p>	<p>1s</p>
<p>Actual logged alarms</p>	<p>6 (02:33:23.369 ~ 02:33:28.506)</p>
<p>Alarm should be logged during the period (02:33:23.369 ~ 02:33:28.506)</p>	<p>6</p>
<p>Success rate</p>	<p>100%</p>

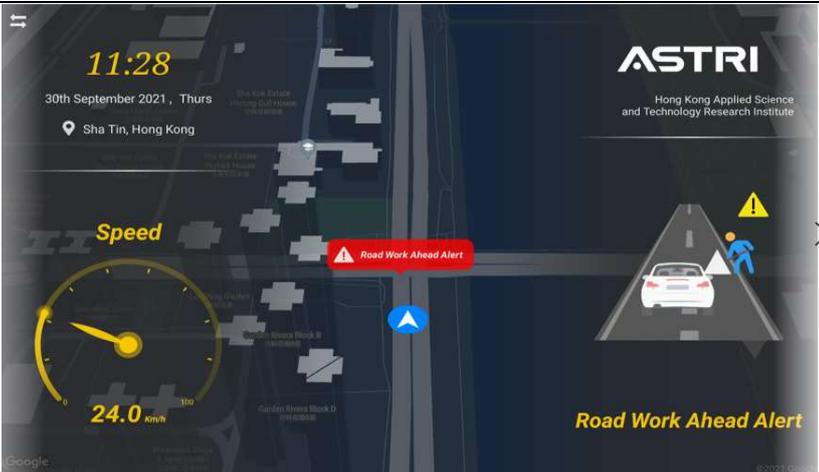
Table 4-6 Test Results of Road Works Warning

Simulated event location and vehicle direction (red arrow)	
Event sending interval	1s
Actual logged alarms	10 (02:46:05.510 ~ 02:46:14.620)
Alarm should be logged	10

during the period (02:46:05.510 ~ 02:46:14.620)	
Success rate	100%
Tablet App Capture

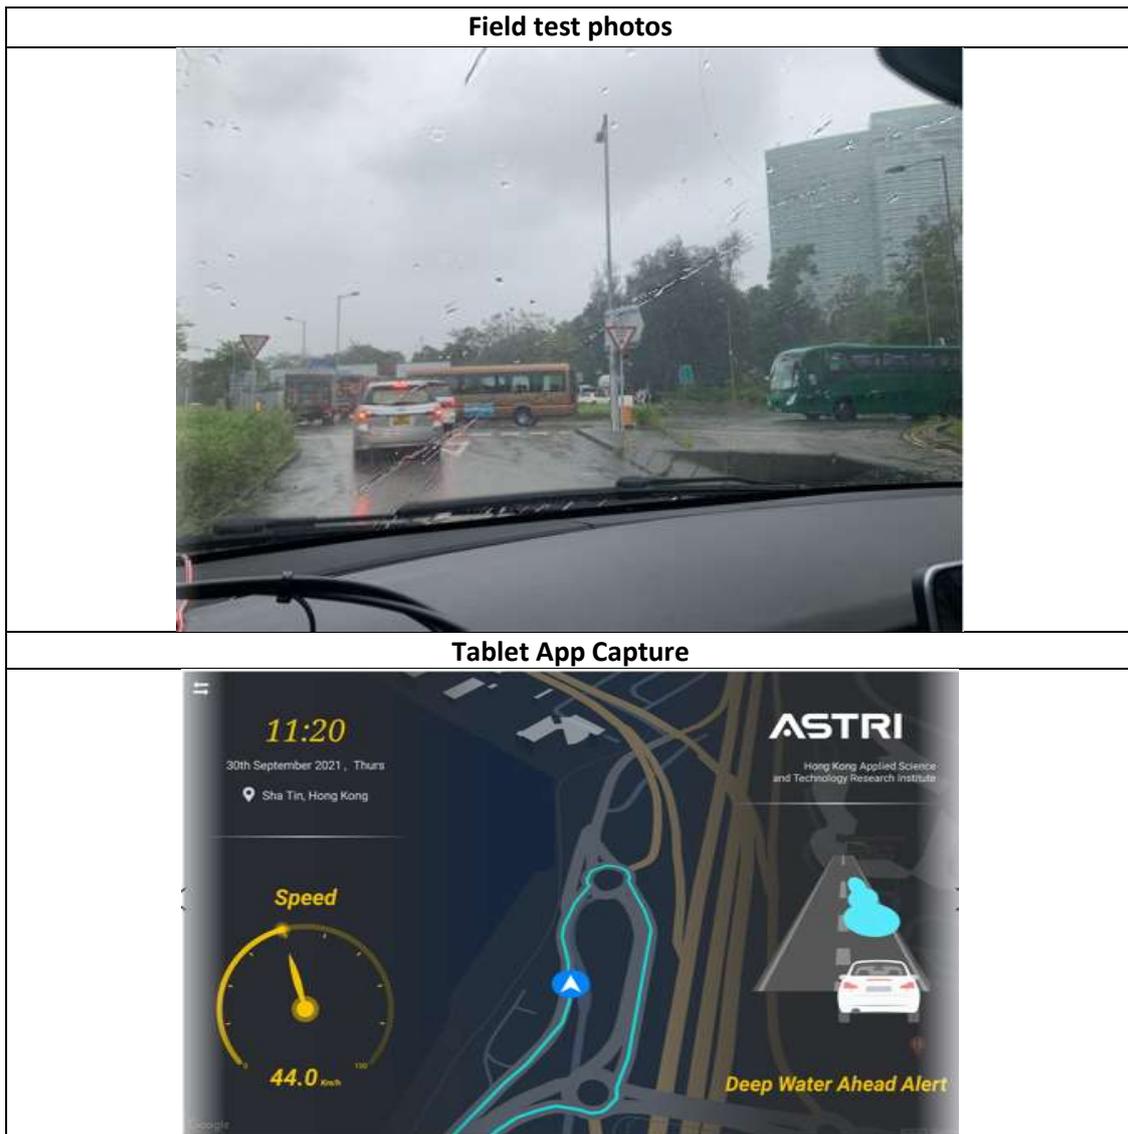
Table 4-7 Hazardous Location Warning Test Results

The scenario was when the host vehicle was driving toward the road section with dangerous situations including deeper stagnant water, pavement pit, slippery road, and sharp turn ahead, which would expose to a risk of an accident.

The “Hazardous Location Alert” would be sent from C-V2X RSU to the ASTRI’s In-vehicle software via C-V2X OBU installed in the host vehicle, using the V2I PC5 communications channel. ASTRI’s In-vehicle software and Display App in the host vehicle would generate and display the “Hazardous Location Warning” (HLW) to alert the driver.

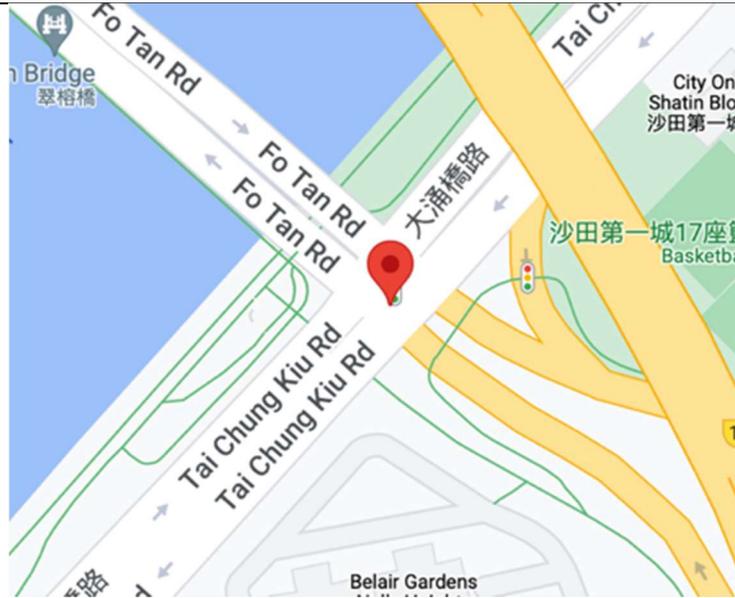
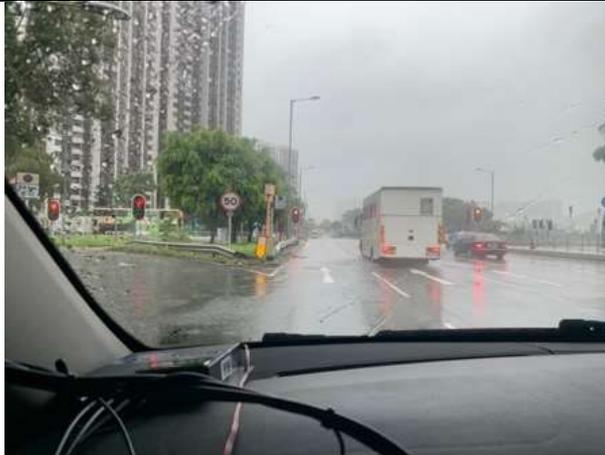
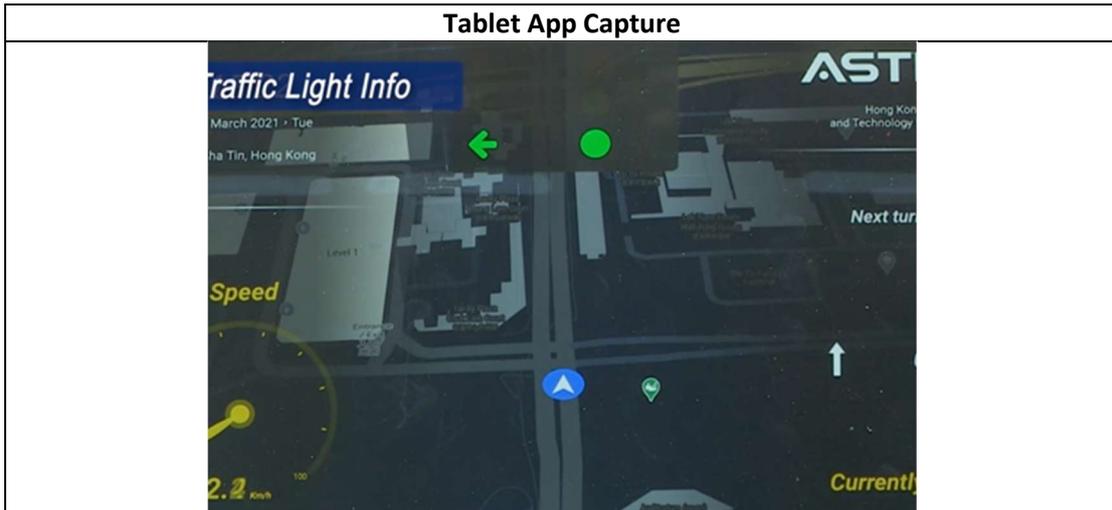
Table 4-8 Test Results of Traffic Light Information

When the host vehicle (HV) drove to the configured location, the application would broadcast the messages of Traffic Light Information (TLI) including vehicle position, type, and description, etc. In addition, the related alarm log which includes alert type, latitude, longitude, and alert description would be generated in the backend server.

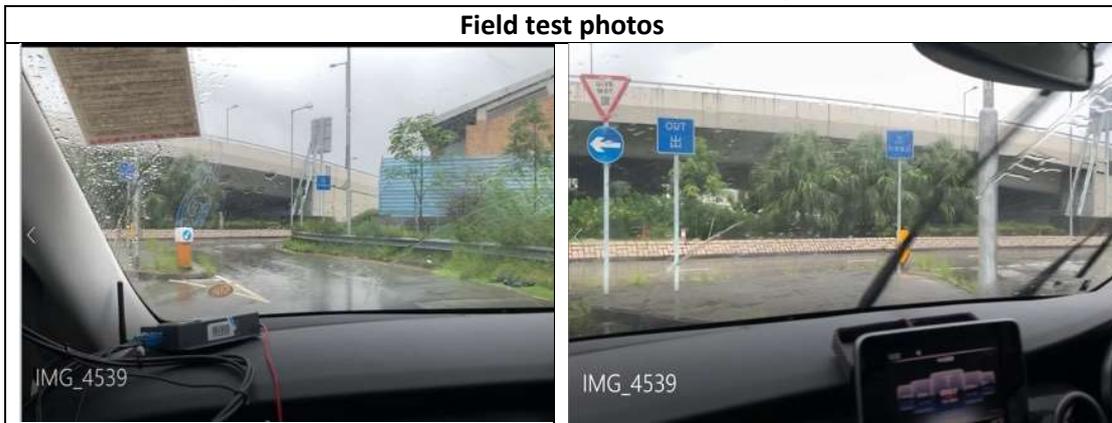
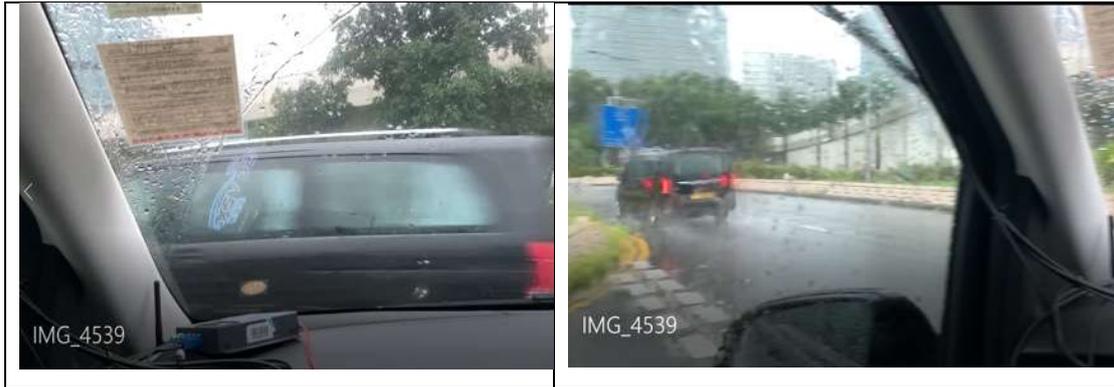
Table 4-9 Test Results of Intersection Warning – 1

Intersection Warning use case was tested with both of the 10-MHz and 20-MHz Channels. The test results under the two different bandwidths were both successful. The host vehicle (HV) and the remote vehicle (RV) were equipped with V2X devices. The HV was driving toward the intersection road while, at the same time, the RV was driving toward the sideways. When HV was ready to enter the intersection, the application detected the intersection alarm and would broadcast messages of Intersection Warning (IW) including vehicle position, type, and description, etc. In addition, the related alarm log which includes alert type, latitude, longitude, and alert description would be generated in the backend server.

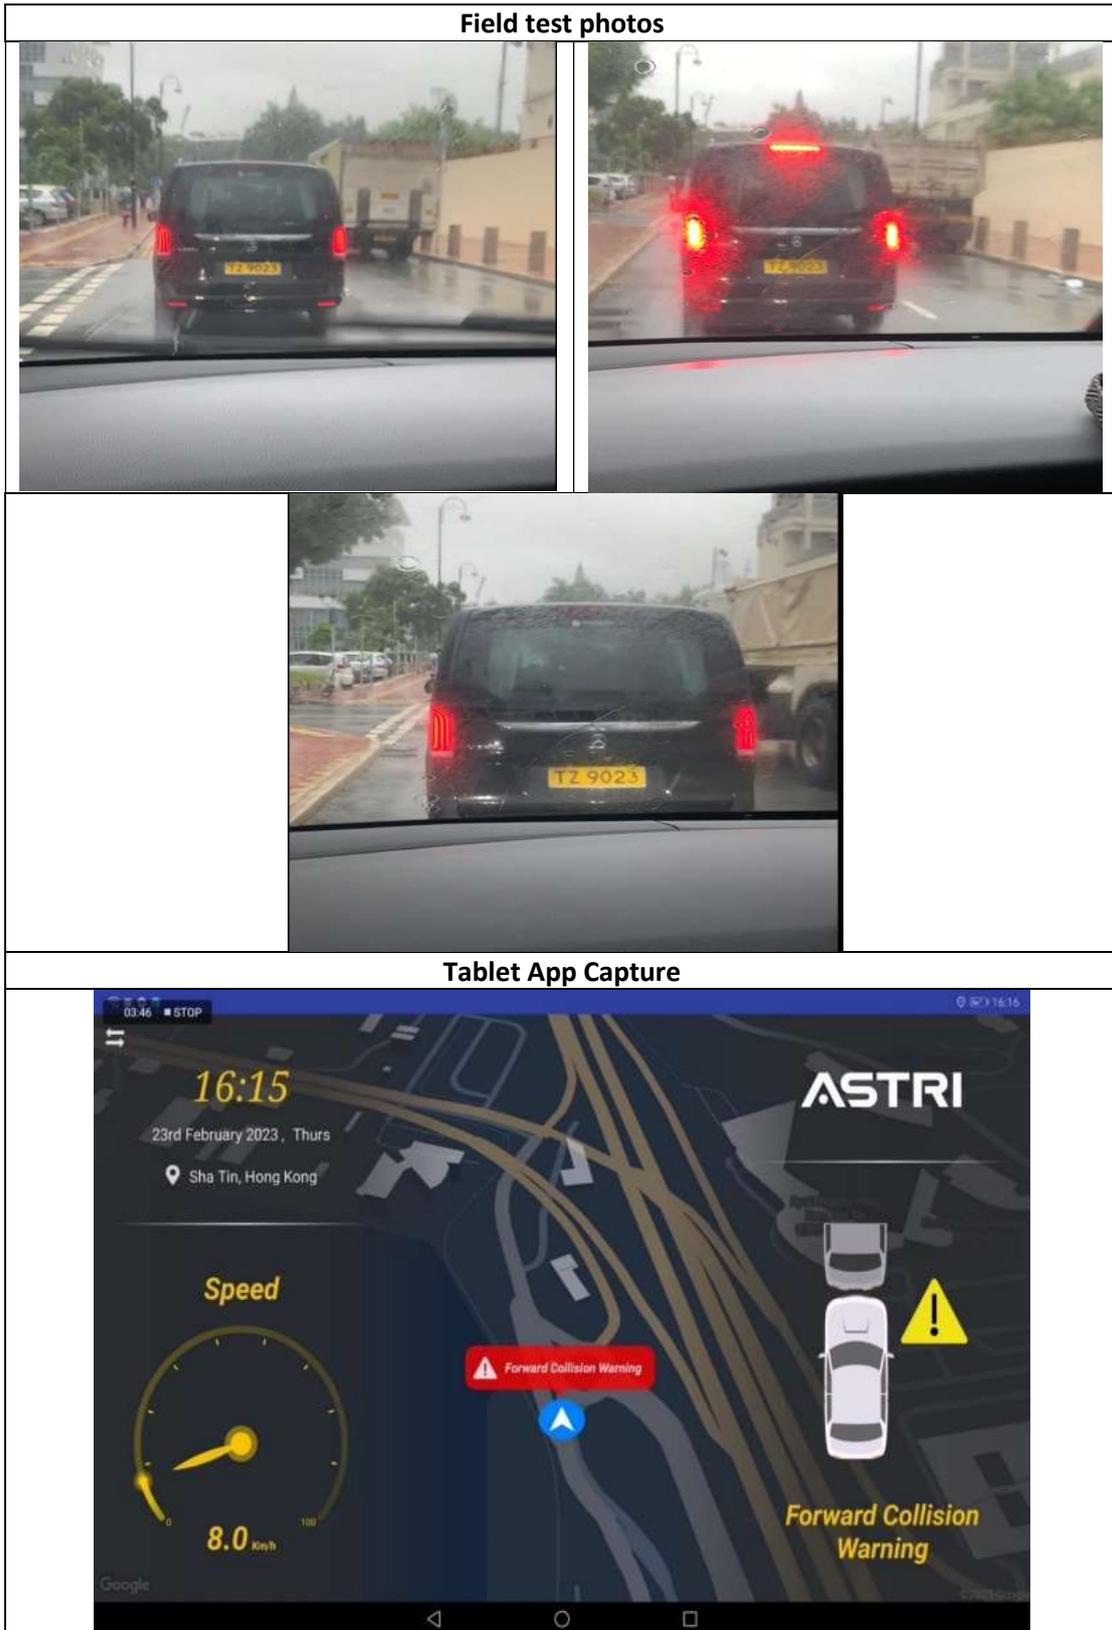
Table 4-11 Test Results of Forward Collision Warning

Forward Collision Warning use case was tested with both of the 10-MHz and 20-MHz Channels. The test results under the two different bandwidths were both successful. The host vehicle (HV) and the remote vehicle (RV) were equipped with V2X devices. The host vehicle (HV) was following the remote vehicle (RV) at a very close distance. When the RV was driving slowly or decelerating, the application detected the front collision alarm and would broadcast messages of Forward Collision Warning (FCW) including vehicle position, type, and description, etc. In addition, the related alarm log which includes alert type, latitude, longitude, and alert description would be generated in the backend server.

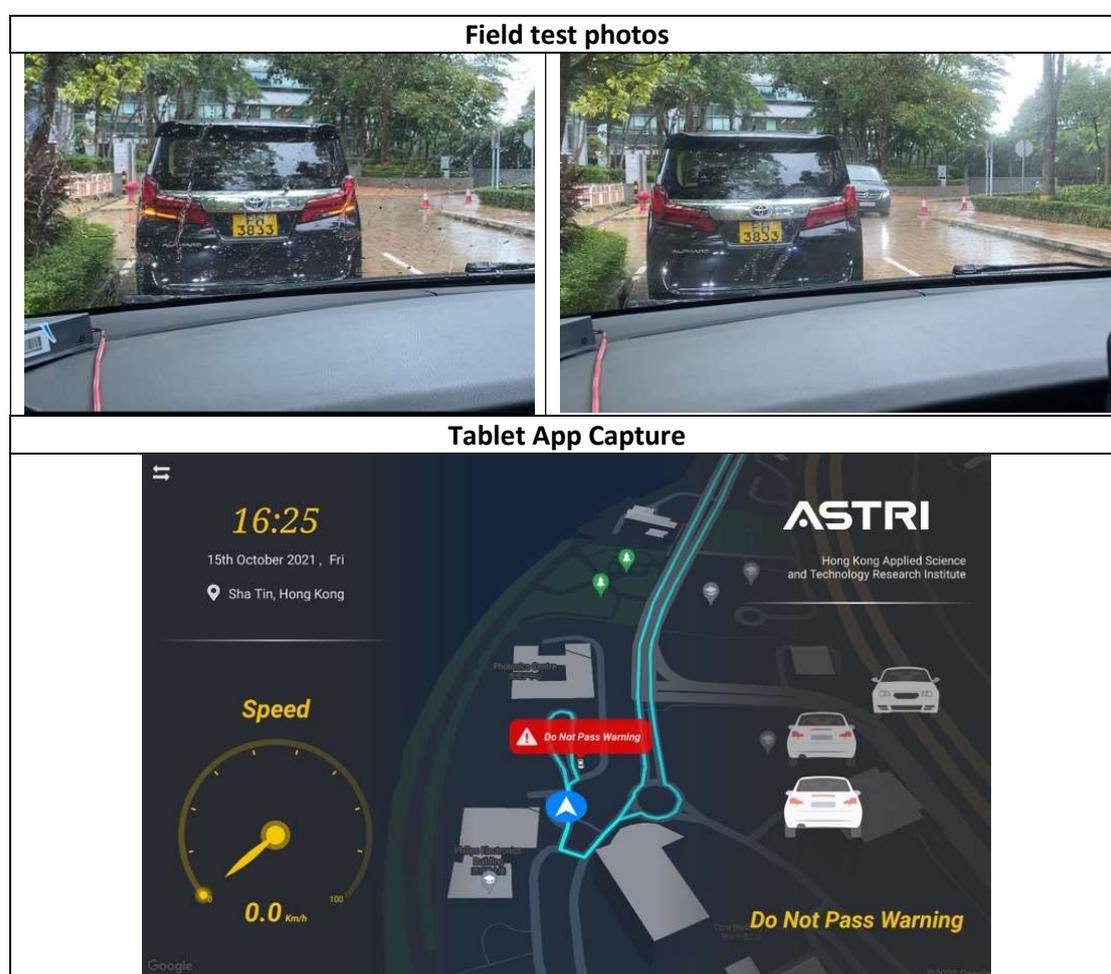
Table 4-12 Test Results of Do Not Pass Warning

HV was following RV-1 and trying to pass RV-1. RV-2 was coming on the reverse lane (from the opposite direction with HV and RV-1) and RV-1 may block the view of HV. When HV sent out the lane change signal and prepared to enter the reverse lane, the application would warn the driver of HV with Do Not Passing Warning (DNPW) including vehicle position, type, and description, etc. In addition, the related alarm log which includes alert type, latitude, longitude, vehicle information and alert description would be generated in the backend server.

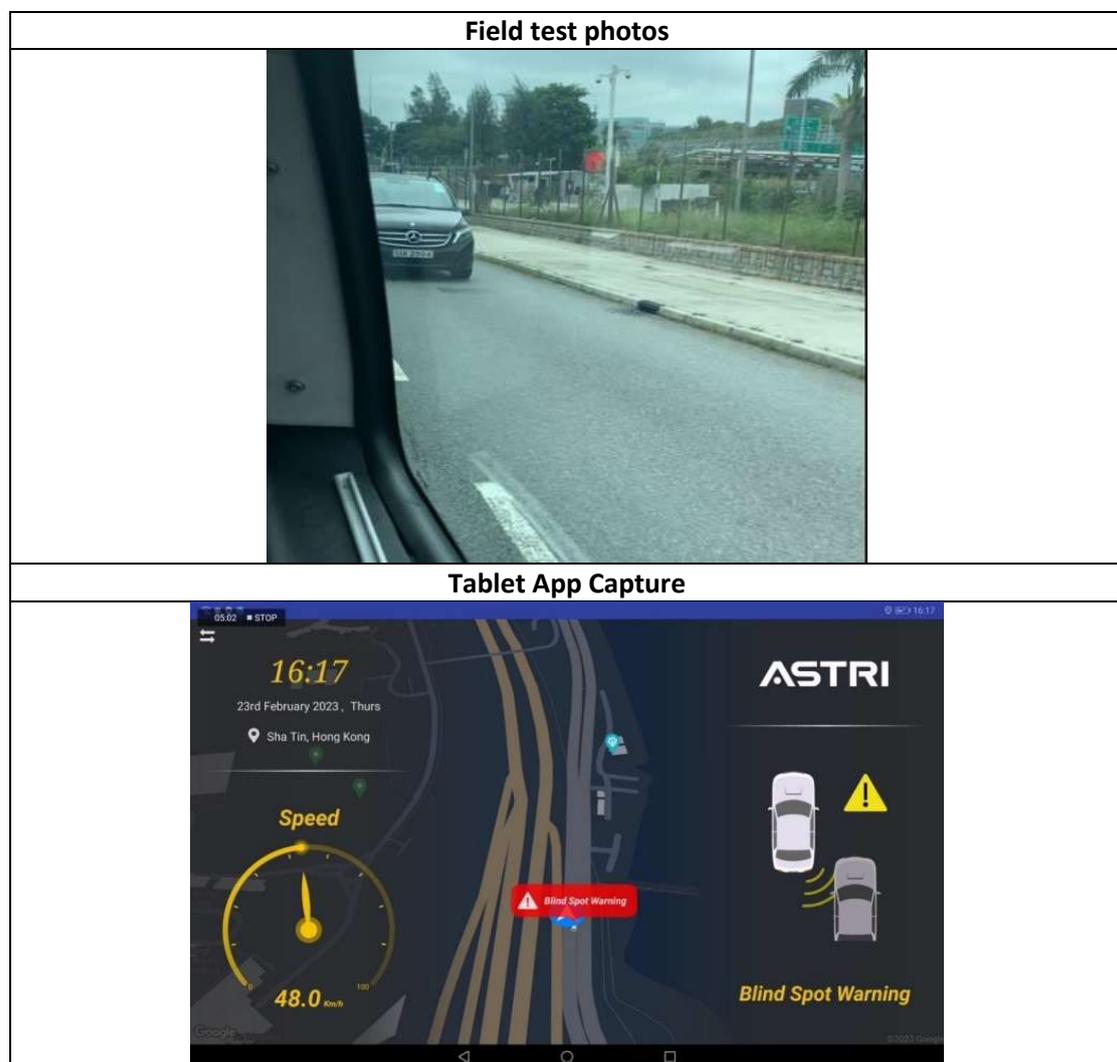
Table 4-13 Test Results of Blind Spot Warning

When HV was travelling on the main road, there was RV coming in “blind spot” of HV on the adjacent road. In this case, the application would warn the driver of HV with Blind Spot Warning (BSW) including vehicle type, and description, etc. In addition, the related alarm log which includes alert type, latitude, longitude, vehicle information and alert description would be generated in the backend server.

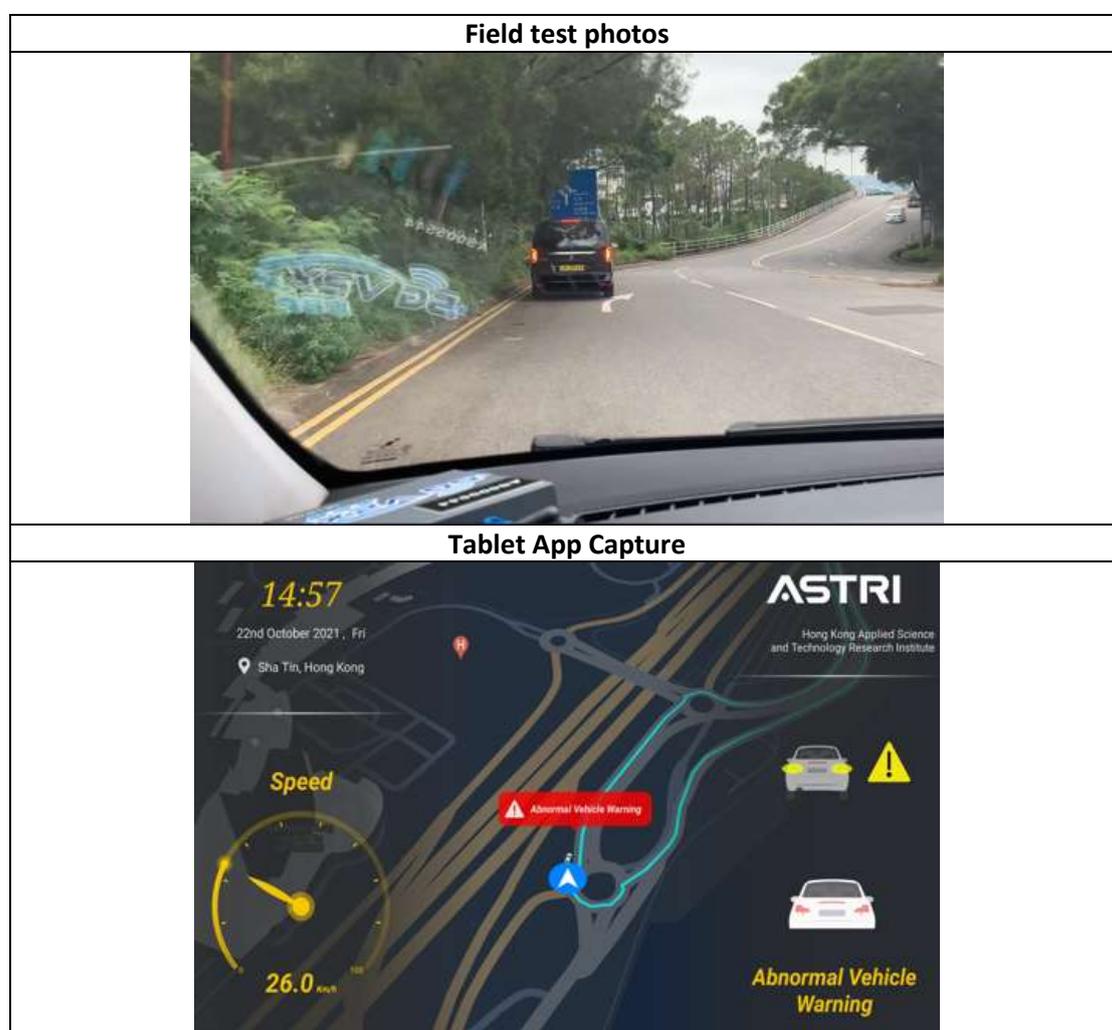
Table 4-14 Test Results of Abnormal Vehicle Warning

When the host vehicle (HV) was traveling on the main road, and there was an “abnormal” remote vehicle (RV) ahead (or even in a blocking sight situation). In this case, the application would warn the driver of HV with Abnormal Vehicle Warning (AVW) including vehicle type, description, etc. In addition, the related alarm log which includes alert type, latitude, longitude, and alert description would be generated in the backend server.

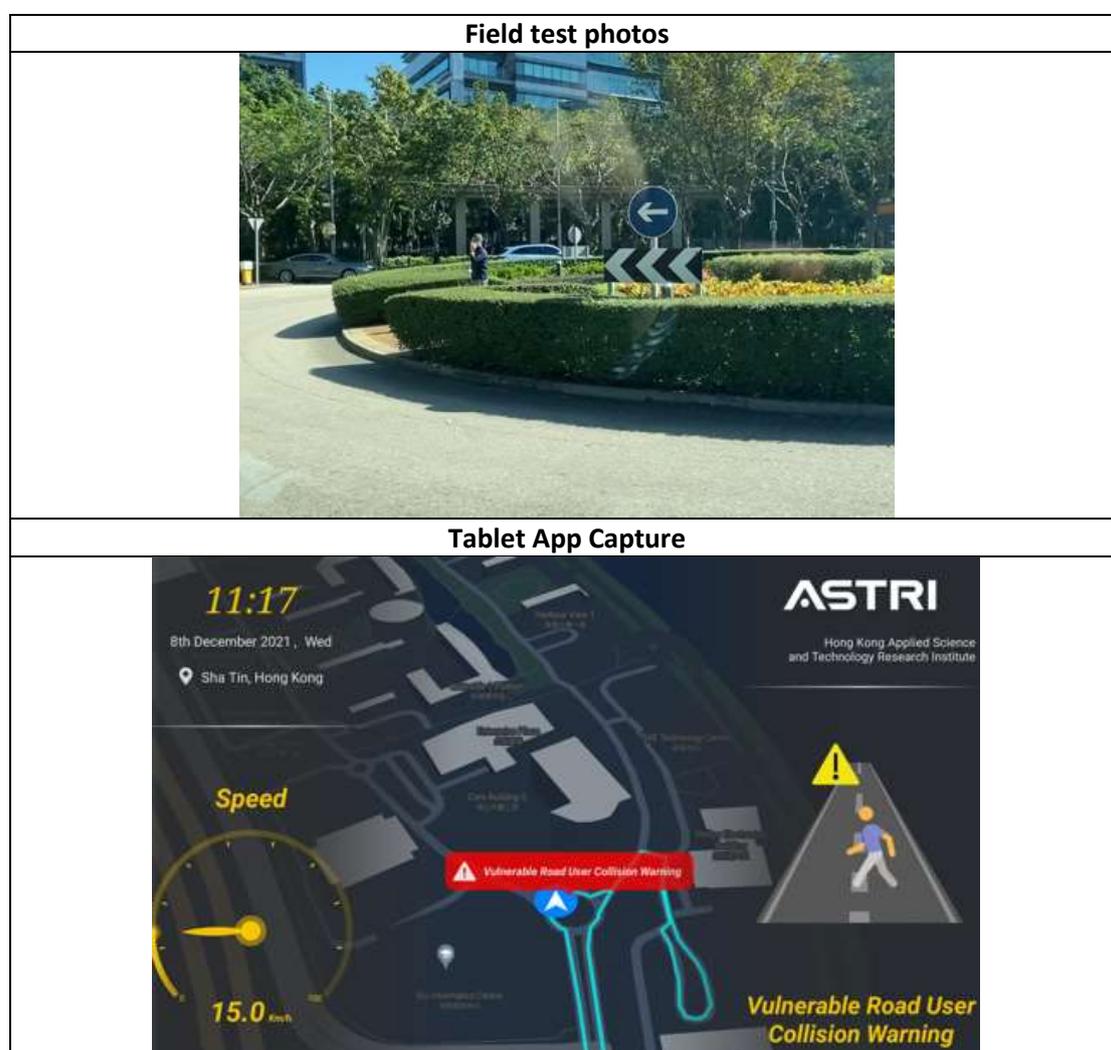
Table 4-15 Test Results of Roundabout Pedestrian Warning

When the host vehicle (HV) was traveling on the main road, the pedestrians would cross the road by sight blocking situation (e.g. pedestrians are blocked by green belts, etc.) such that the incoming HV drivers on the main road could not see them. In this case, the application would warn the driver of HV with a Vulnerable Road User Collision Warning (VRUCW) including vehicle type, description, etc. In addition, the related alarm log which includes alert type, latitude, longitude, and alert description would be generated in the backend server.
