Summary Report

Trial of C-V2X Radio Equipment Operating in the 5905-5925 MHz Band

Applied Science and Technology Research Institute Limited
5th Floor, Photonics Centre
2 Science Park East Avenue
Hong Kong Science Park, Shatin
New Territories, Hong Kong
Telephone: +852 3406 2800
Fax: +852 3406 2801
Web: www.astri.org

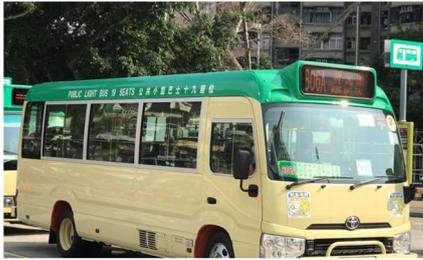
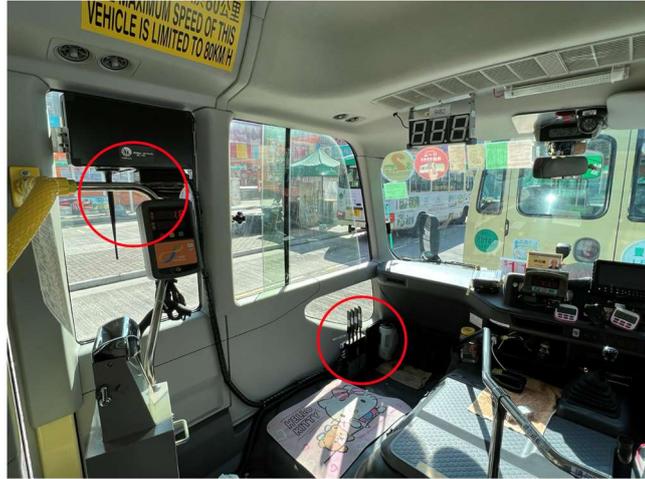
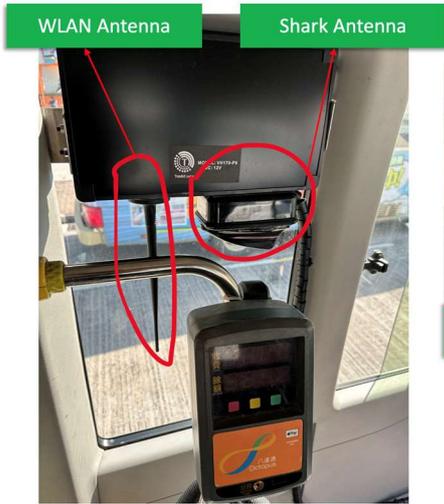
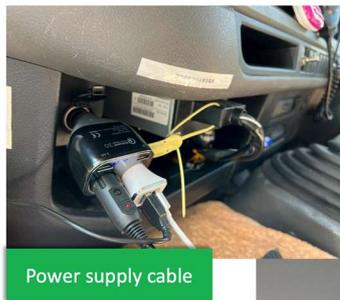
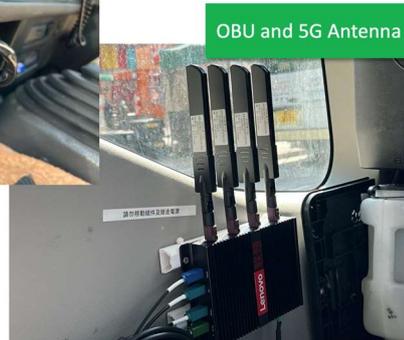
Figure A-1 OBU Installed on Green Minibus

Install 5G OBU on Green Minibus to enable C-V2X on public transport vehicles.
